Manhole Inspection Summary

Manhole # S43CC_105MH

Record Plat: **43CC** Node: **105** Status: **New Manhole (Not in GIS)** Insp Date: **11/20/08 12:00 AM**

Location Address: **1715 eager st**

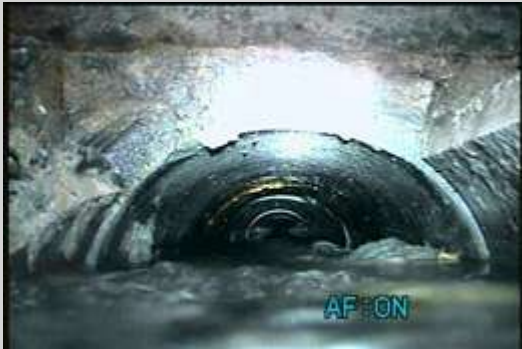
12 O'Clock Outflow

12 in. Circular Gravity Sewer
Pipe Out @ 12 O'Clock

Deposits: ☒ None ☐ Mud ☐ Sludge ☐ Debris ☐ Grease

Infiltration: **None** Pipe Seal Cond: **Unknown**

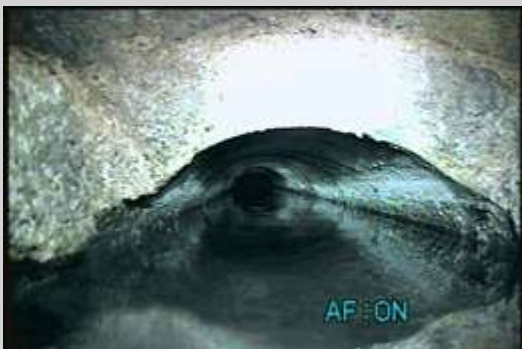
6 O'Clock Inflow

12 in. Circular Gravity Sewer
Pipe In @ 6 O'Clock

Deposits: ☒ None ☐ Mud ☐ Sludge ☐ Debris ☐ Grease

Infiltration: **None** Pipe Seal Cond: **Unknown**

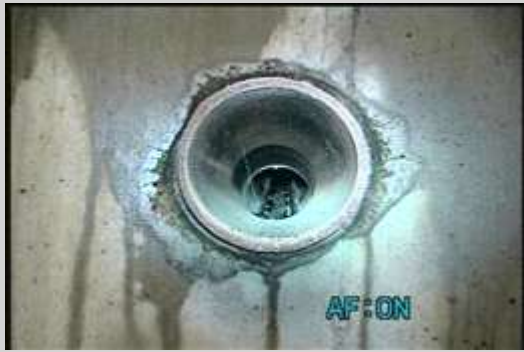
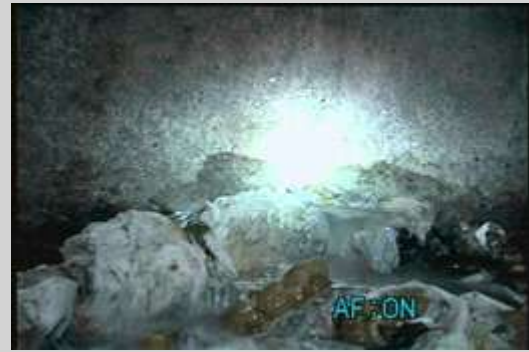
9 O'Clock Inflow

8 in. Circular Gravity Sewer

Pipe In @ 9 O'Clock

Drop In @ 9 O'Clock

Infiltration: **None**

Drop Condition: **Open**
